# Orson Fowler's Influence in the Shenandoah Valley: Gravel Wall Buildings in Augusta County, Virginia.

ORSON FOWLER'S INFLUENCE IN THE SHENANDOAH VALLEY:  
GRAVEL WALL BUILDINGS IN AUGUSTA COUNTY, VIRGINIA

In Partial Fulfillment  
of the Requirements for the Degree  
Master of Science  
Historic Preservation

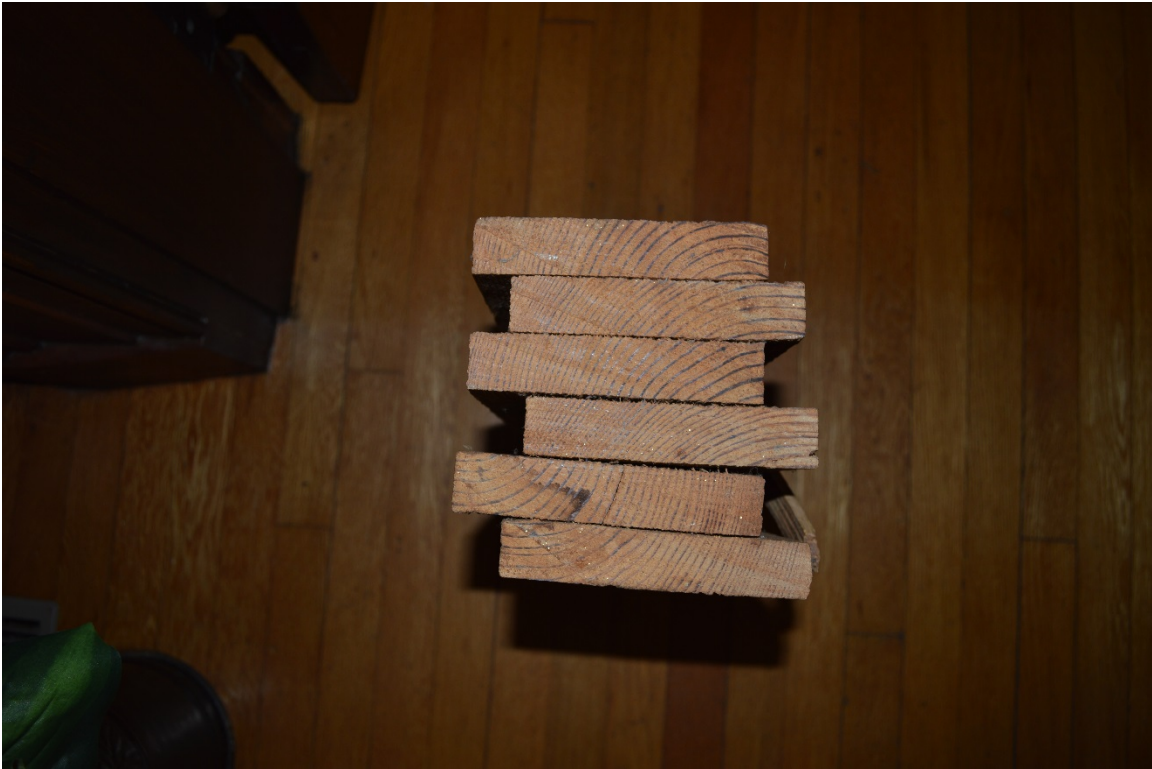
Figure 4.1: A section of board-wall from the McCue House (AU23). Notice that the boards are offset from one another, as Fowler suggests. Photo: author, 2017.

Orson Fowler advocated for board-wall construction in the first edition of *A Home for All*, released in 1848. In this method of construction, walls were built using sawn boards stacked one upon another (Figure 4.1). In 1853, Orson Fowler released his third edition, in which he replaced the board-wall method of construction with a new material and method: the gravel wall. While only one example of board-wall construction has been identified in Augusta County, at least forty-six gravel wall buildings exist in the county. The gravel wall's modest popularity in Augusta County between 1859 and 1900 can be attributed to a number of factors. Fowler outlined the gravel wall plan in selective detail in *A Home for All*. Some facets of the process were described in detail, such as the construction and erection of formwork to pour the walls. Other details, such as the proportions of ingredients in the gravel wall, were given in more general terms. This ambiguity left much open to interpretation, as is evident with builders in Augusta County.

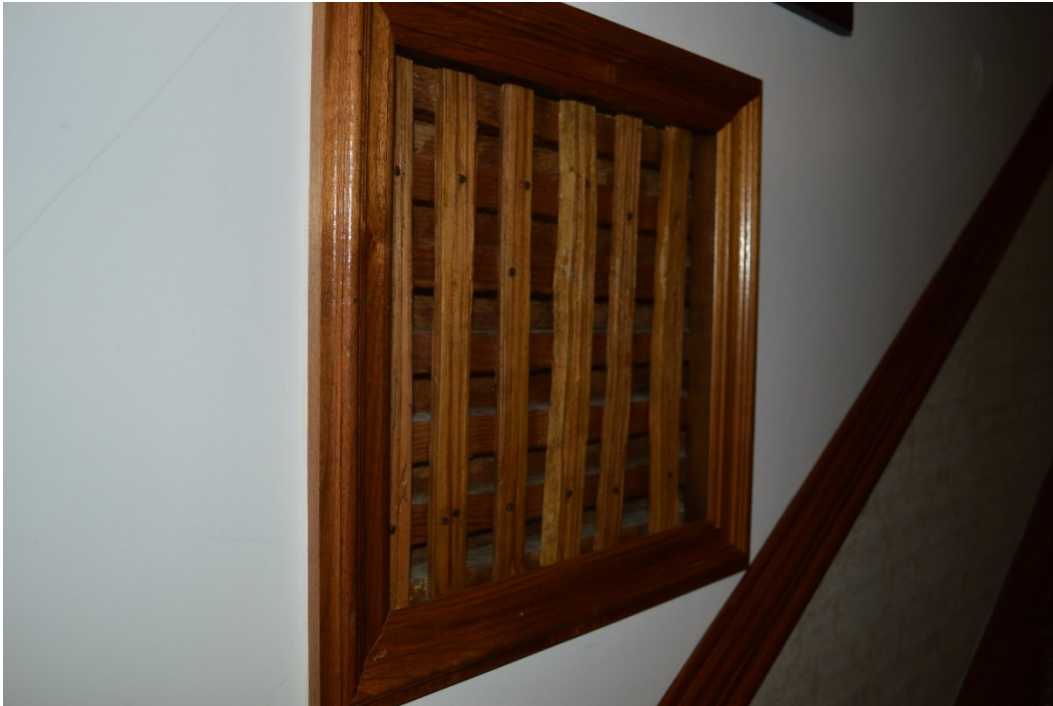
Figure 4.4: A window added by the current owner of the McCue House that shows the board-wall and vertical lath.  
Photo: author, 2017.

<sup>69</sup> Vertical lath was also found at the James Harris Callison House, an 1849 log house near Newport, in the southern portion of Augusta County. The house is currently undergoing demolition.

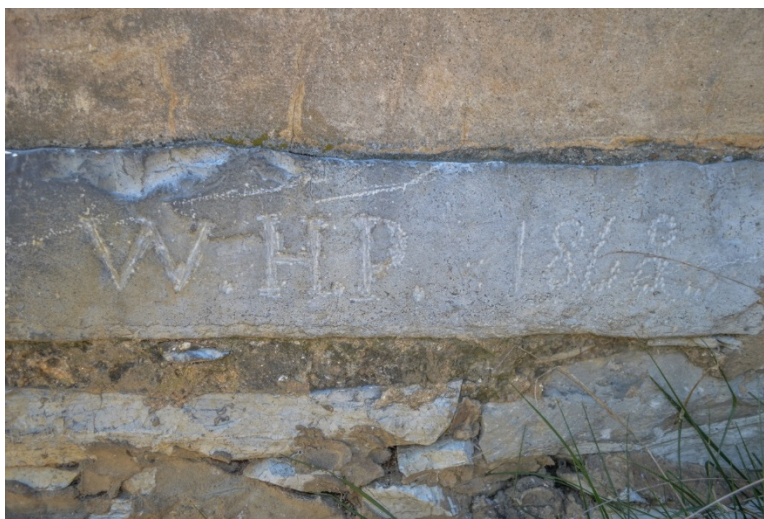
Figure 4.8: A carved cornerstone at the 1868 Switzer House, signed by William H. Peterson. Photo: author, 2017.

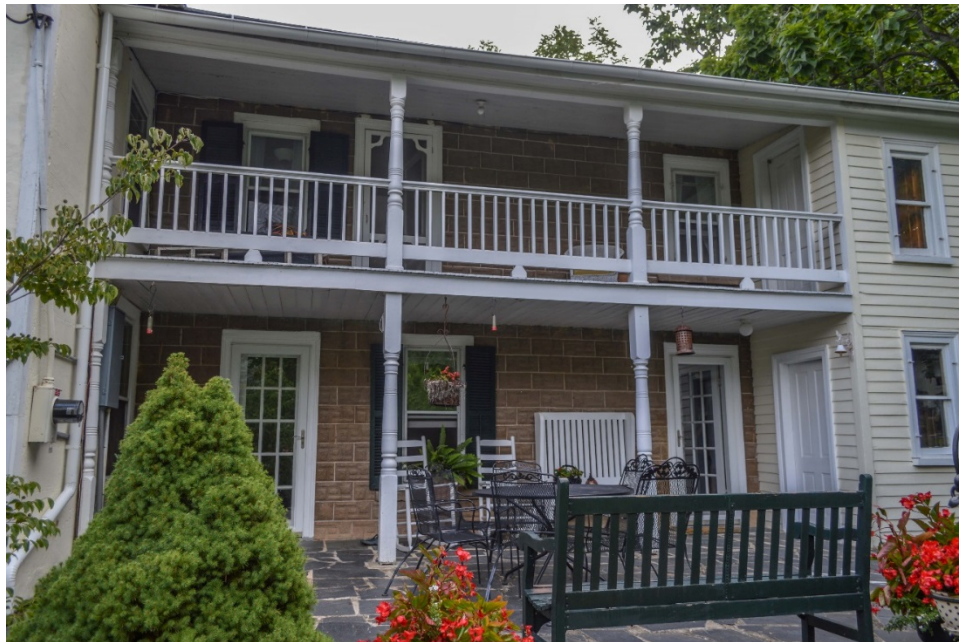
Figure 5.1: The rear ell of the Rissmeyer-Murray House. Photo: author, 2017.

Located in a cluster of gravel wall buildings centered around the community of Roman, Virginia, the Rissmeyer-Murray House was built as a gravel wall I-house. Just after the turn of the century, a textured concrete block ell was added onto the rear of the house (Figure 5.1 and Figure 5.2). According to the current owners of the Rissmeyer-Murray House, a man who was a boy during the construction of the ell recalled observing the builder's process of making and laying concrete block. The builder arrived at the site with a machine to make the blocks. The man recalls that the builder mixed the ingredients for the blocks, using sand which was procured from the nearby Middle River. This process of sand extraction from nearby sources, when coupled with the mixing of material onsite, resonates to gravel wall construction. In gravel wall construction, lime was sometimes burned on-site to create the slaked lime necessary for use as a binder, sand was extracted from nearby rivers and streams, and stone was readily available from nearby sources. Concrete block, for comparison, also used sand, gravel, and cement. While sand and gravel were still readily available resources in Augusta County, hydraulic cement was a new luxury for builders. The discovery and commercialization of cement created an industry that fueled this shift from gravel wall to concrete block.

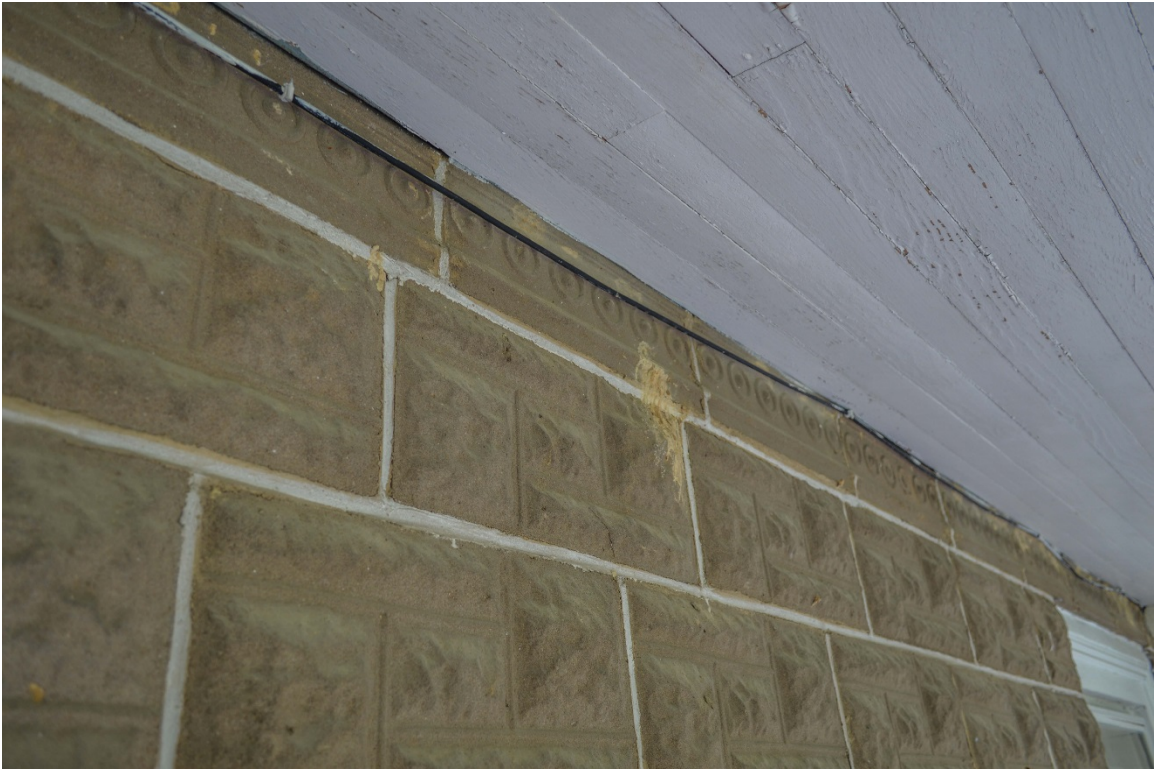
Figure 5.2: Concrete block detail, Rissmeyer-Murray House rear ell. Photo: author, 2017.

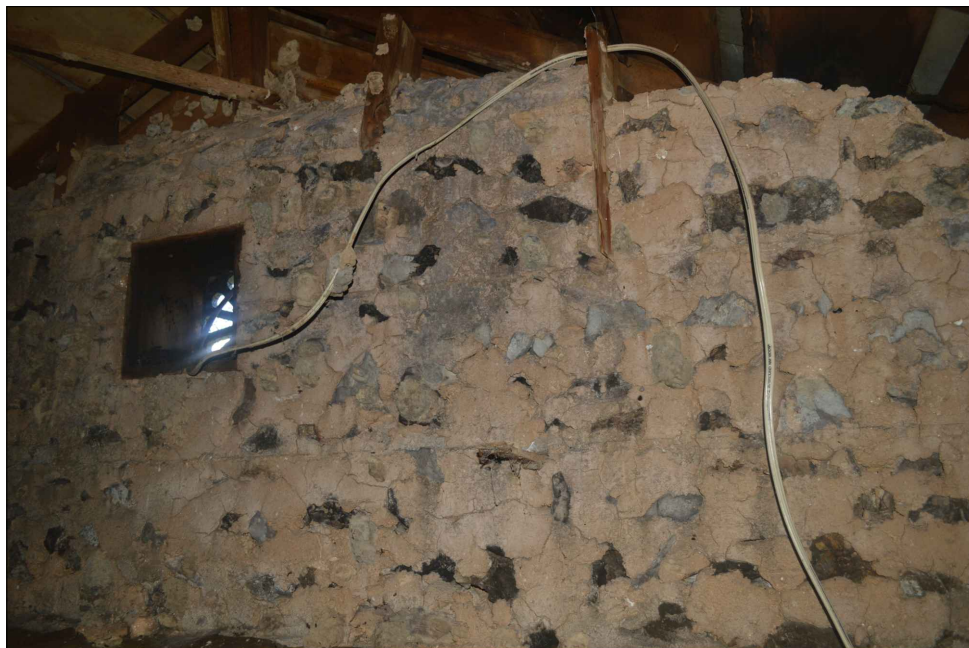
Photo: Interior detail of gravel wall construction, taken from the attic. Author, 2017.

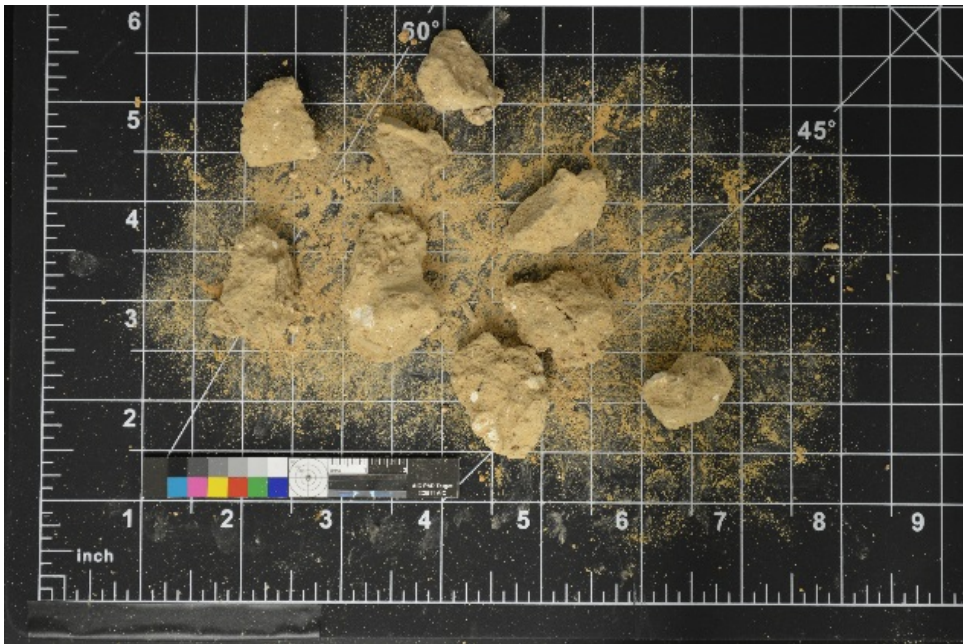
<u>Mass of container</u> 1.87 g	<u>Mass of sample and container</u> 33.53 g	<u>Mass of sample</u> 31.66 g
<b>Components: after acid digestion</b>		
Fines:	% Weight: 53 %	Weight: 16.89 g
	Organic matter: none	
	Color: Munsell 7.5YR 7/4	
Binder:	% Weight: 27 %	Weight: 8.67 g
	Description of reaction: highly reactive	
	Binder type: lime	
Aggregate:	% Weight: 19 %	Weight: 6.09 g
	Sorting: 3	
	Notes: some ferrous aggregate	
<b>Note: Characterization of the sample is achieved through percentages (of fines, binder, and aggregate).</b>

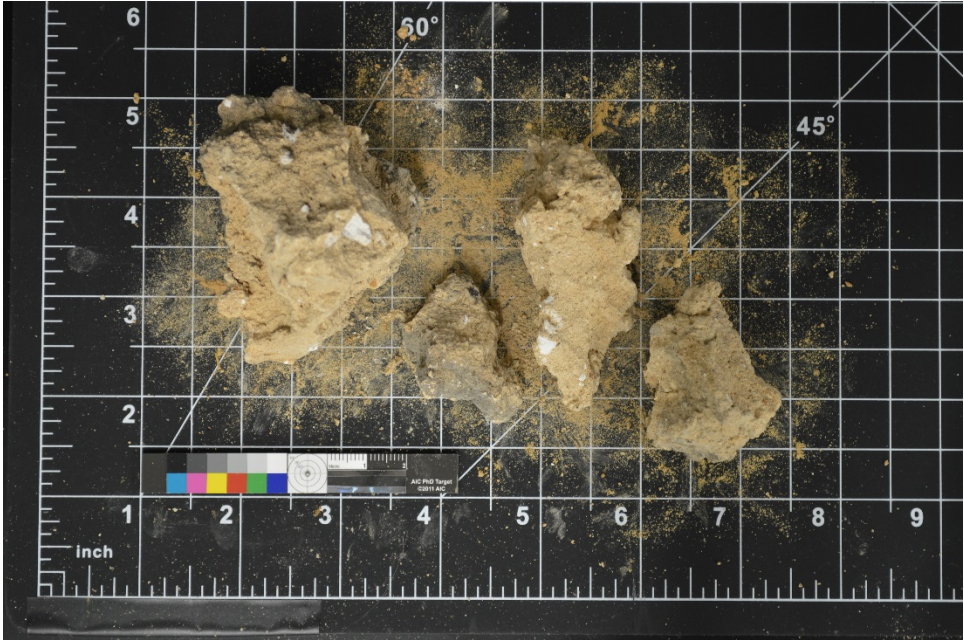
<u>Mass of container</u> 2.27 g	<u>Mass of sample and container</u> 33.36 g	<u>Mass of sample</u> 31.09 g

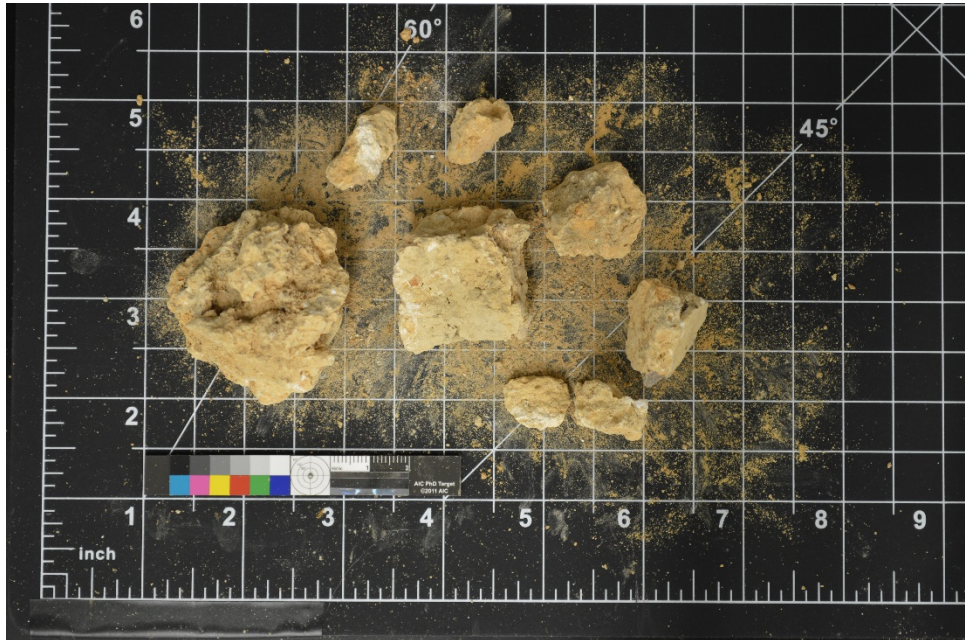
<u>Mass of container</u> 1.83 g	<u>Mass of sample and container</u> 34.65 g	<u>Mass of sample</u> 32.82 g
